# Part IV

# SHA Watershed TMDL

# Implementation Plans

## IV. SHA WATERSHED TMDL IMPLEMENTATION PLANS

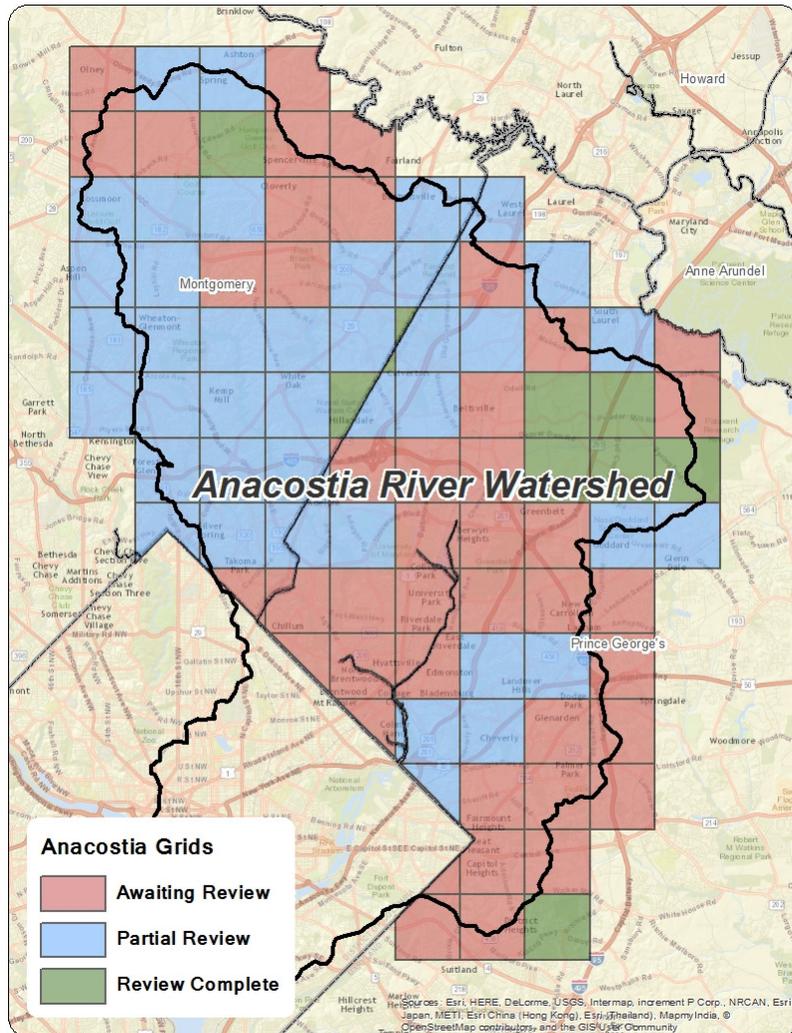
Figure 4-2: Anacostia Site Search Grids

The MS4 permit requires SHA perform visual assessments. **Part III, Coordinated TMDL Implementation Plan** describes the SHA visual assessment process. The implementation teams are currently evaluating grids in the watershed and will continue to do so until all are completed and accepted. The grid-tracking tool was developed to assist teams to efficiently search each watershed on a 1.5 x 1.5-mile square system as shown in **Figure 4-2**. Future planning efforts will continue to be centered on areas with local TMDL needs that have been identified using the site search grid-tracking tool.

Many of the grids awaiting review have little potential for additional impervious treatment due to minimal ROW along residential and wooded areas, which limits the ability to purchase ROW for the construction of a new BMP. The remaining grids needing review will be addressed in future tasks. The current results of this ongoing grid search are as follows:

101 Total Grids:

- Nine fully reviewed;
- 46 partially reviewed - in progress;
- 46 awaiting review (42 percent of total grids);
